PASSAIC RIVER BASIN
RAMSEY BROOK
BERGEN COUNTY
NEW JERSEY

**CRYSTAL SPRING
LAKE
NJ 00231**

**PHASE 1 INSPECTION REPORT
NATIONAL DAM SAFETY PROGRAM**

May, 1979

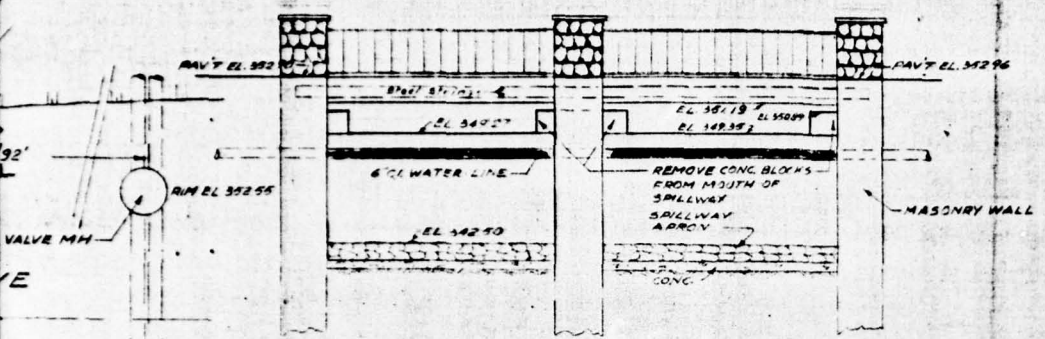
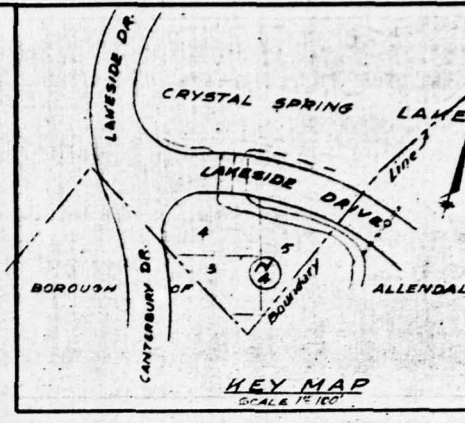
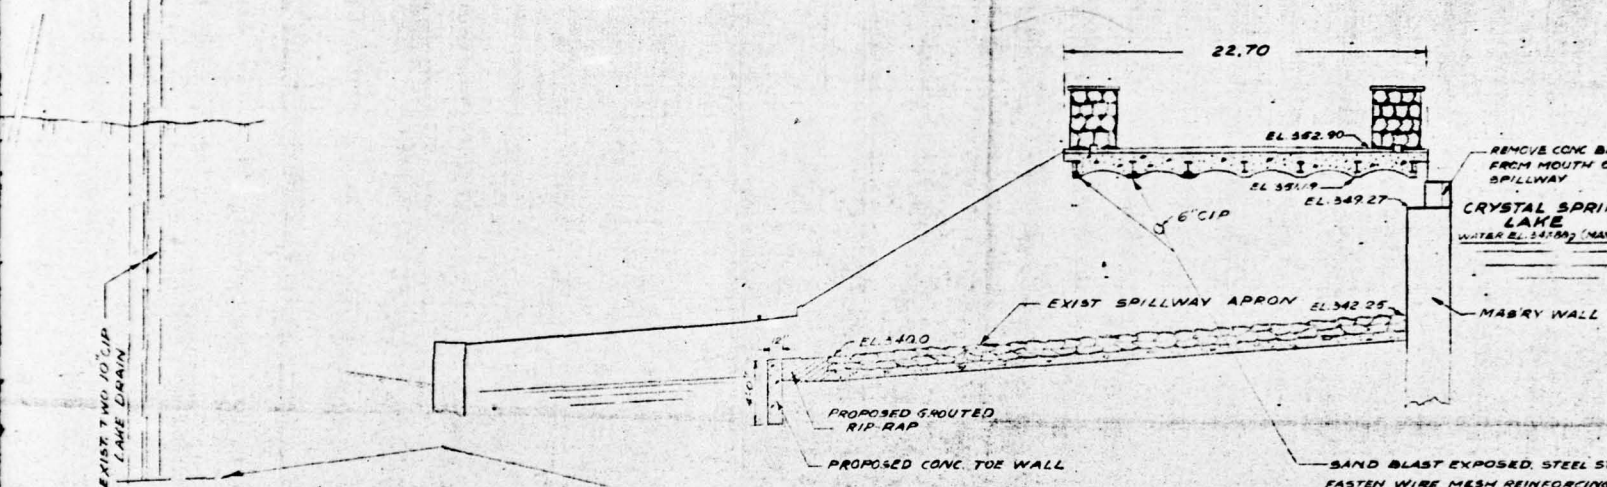
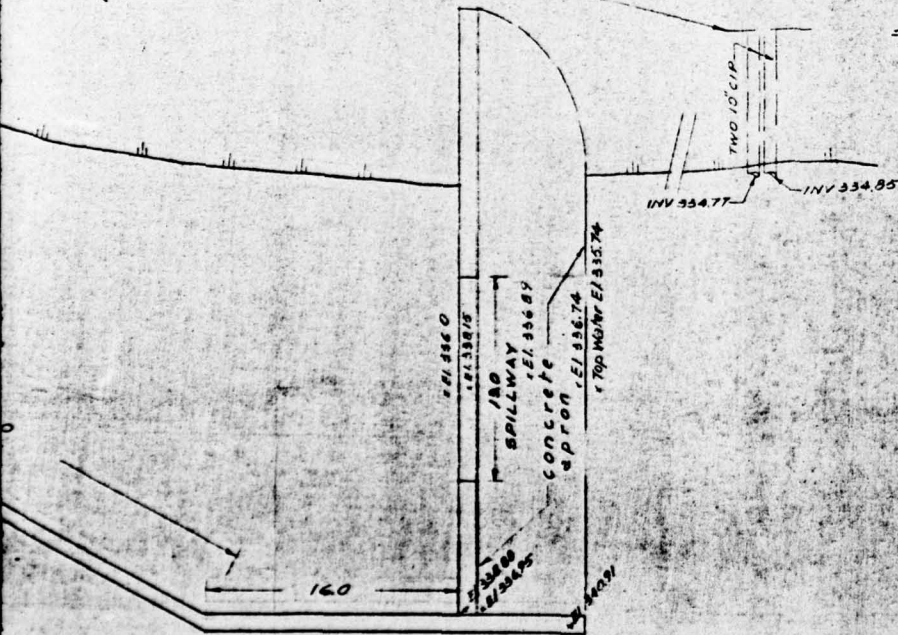
SECTION "A-A"

BOROUGH OF RAMSEY BERGEN COUNTY		NEW JERSEY	
PLAN OF CRYSTAL SPRING LAKE SPILLWAY SHOWING EXISTING CONDITIONS AND MAINTENANCE REQUIREMENTS AT SPILLWAY AND AT ROOF SLAB			
JOB & JOB CONSULTING ENGINEERS 100 HUDSON ST. HACKENSACK, N.J.		DRAWN BY A.S. DATE CHECKED BY K.J. SCALE MAP NO. SHEET 47-36 1 C	
KENNETH G. B. JOB, P.E. PROFESSIONAL ENGINEER N.J. LIC. NO. 1111		DATE 7/11/11

SAND BLAST EXPOSED STEEL ST.
FASTEN WIRE MESH REINFORCING
STRINGERS WITH EXPANSION ANCHORS
AND RESTORE WITH "GUNIT" MORTAR
